General Information

Carrier	PQC
Vessel	PQC VESSEL
Voyage	001 002
Operation	Post-Discharge and Pre-Load
Port	Bremerhaven
Berth	NH AK1

Audit Results

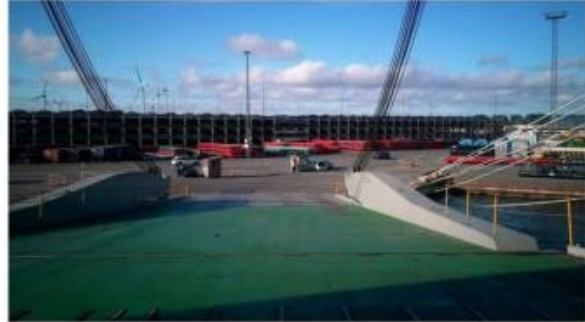
A-1 General condition Terminal.

Operations area next to the ramp was clean and without complaint.

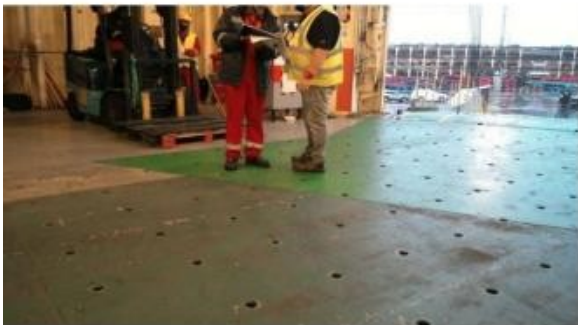
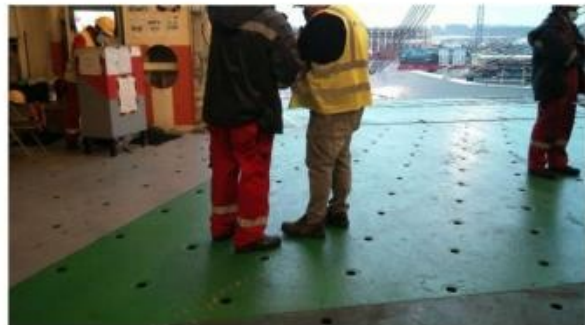
A-2 Communication/Cooperation of all involved parties during operation.

Pre meeting held at security station on main deck. All relevant issues were discussed.

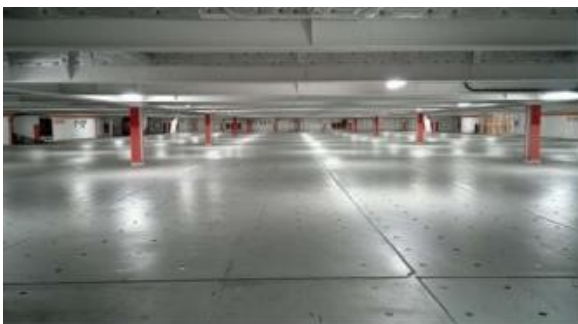
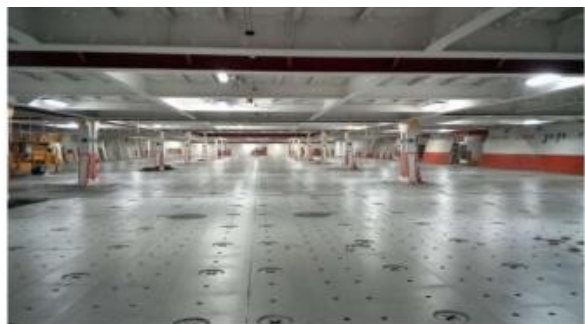
A-3 Decks clean and be in order, dry, well lit and ventilated.

All decks were cleaned up, well lit and good ventilated. Nothing to complain.

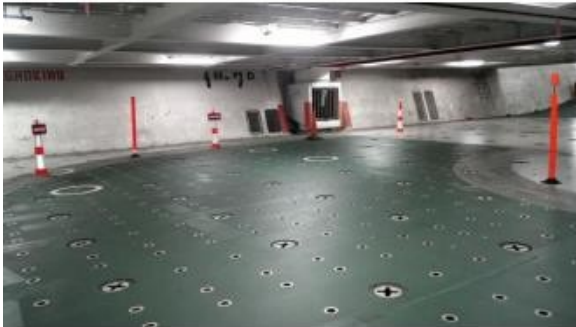
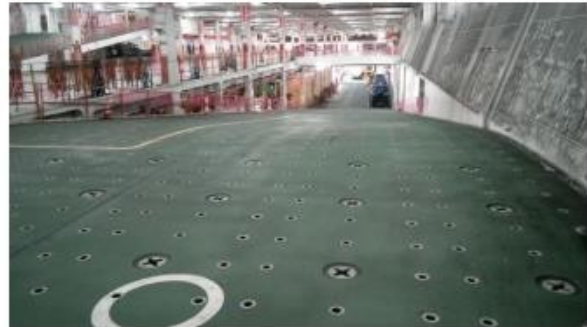
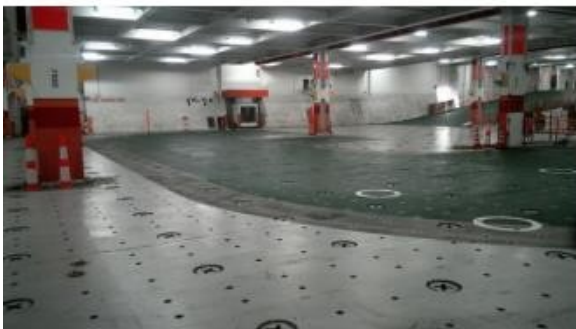
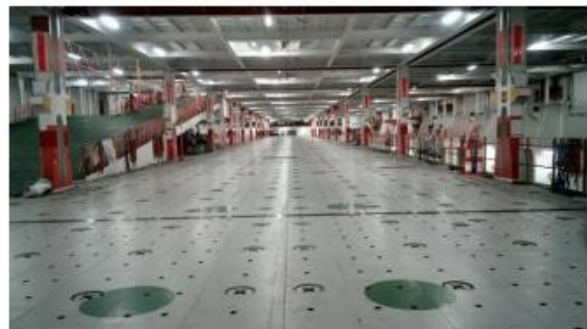
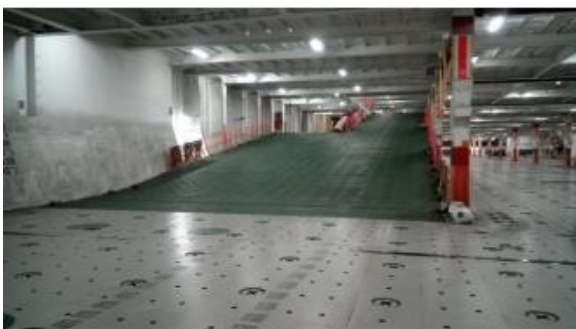
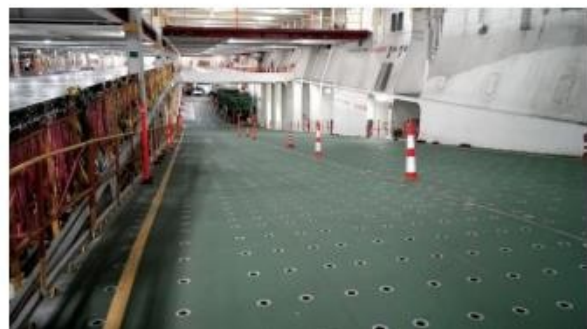
A-4 Driveways and Deck heights clearly marked and proved before commencement of operation.

Driveways were marked good and marking was constantly updated due to the progress of operation.

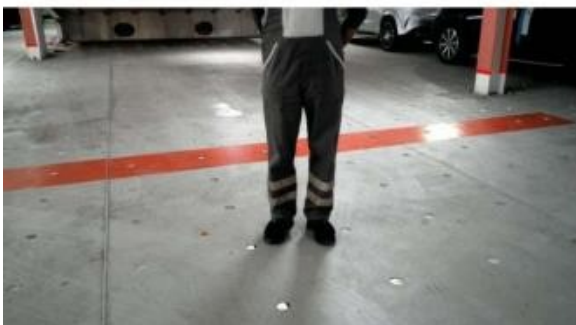
A-5 Dress code Drivers, Stevedores, Lasher and ILA-Crew: clean boilersuits, jackets etc. without metal (no rings, watches ect.).

Drivers dress were clean and without metal applications.

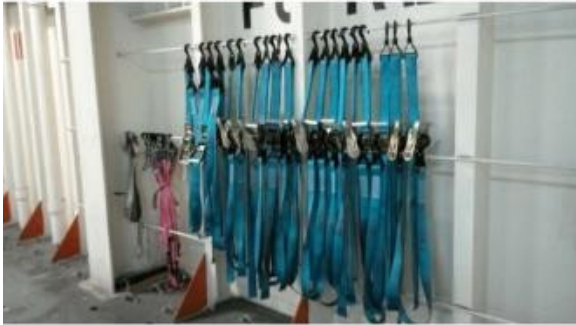
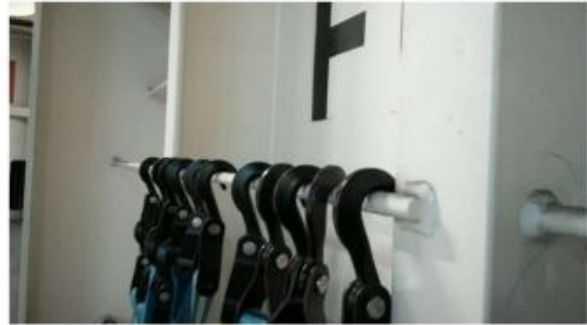
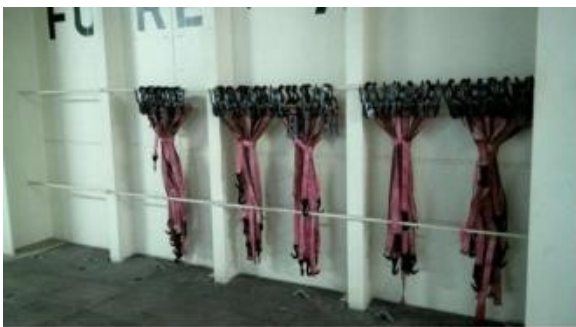
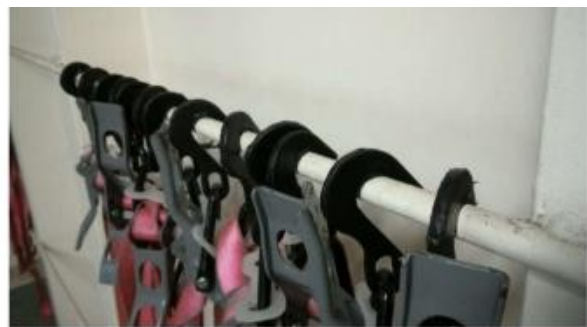
A-6 Lashing material stored in designated places and secured.

Lashing material stored in designated places and secured. Hooks and clasps in good condition.

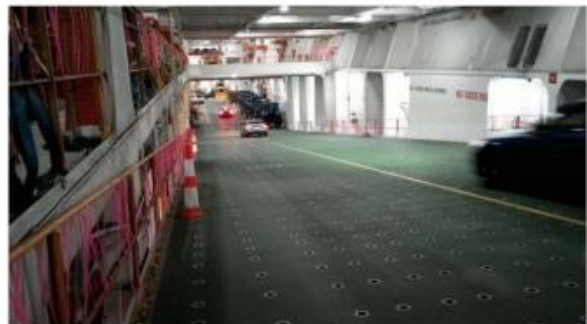
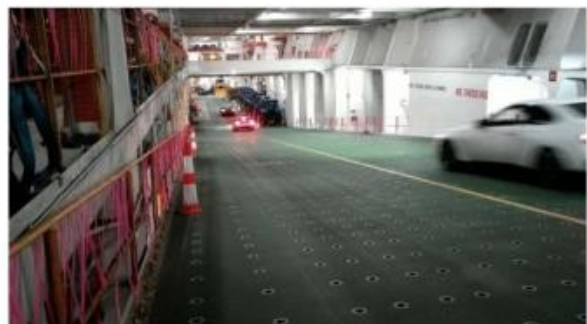
B-1 Safe speed, careful driving and 10m distance between two cars on driveways and ramps.

The drivers drive safely + carefully.

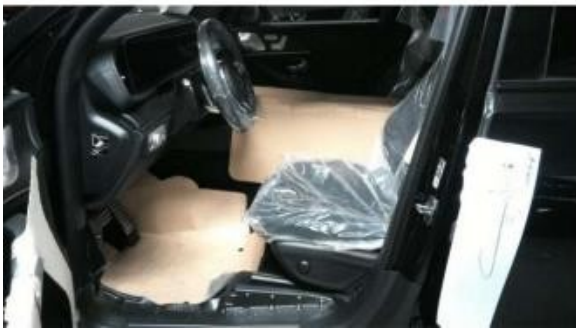
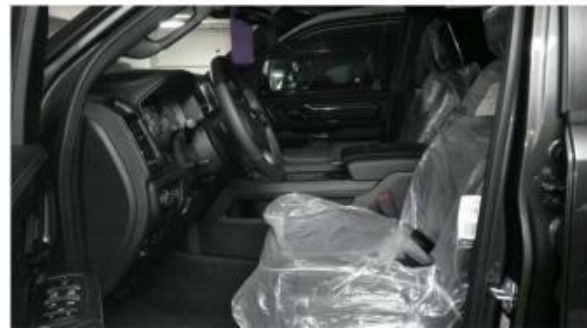
B-2 Vehicles stowed in accordance to the manufactures requirements (key, brake, seatposition, seatcover). Steering wheel in right position.

Meeting the manufactures requirements.

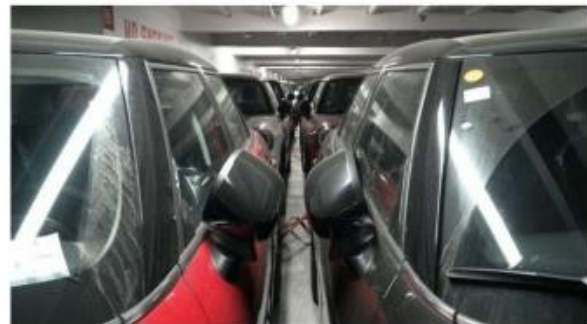
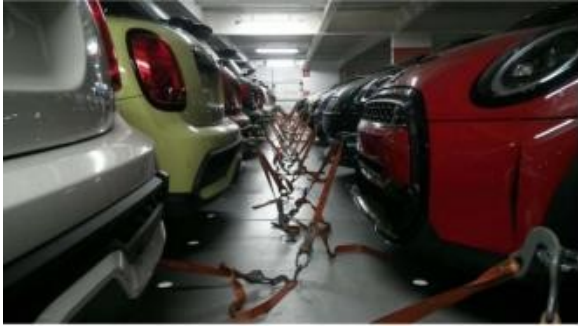
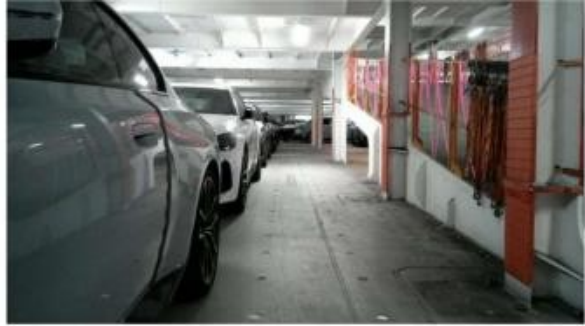
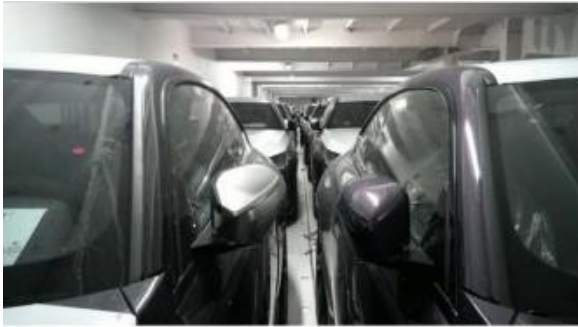
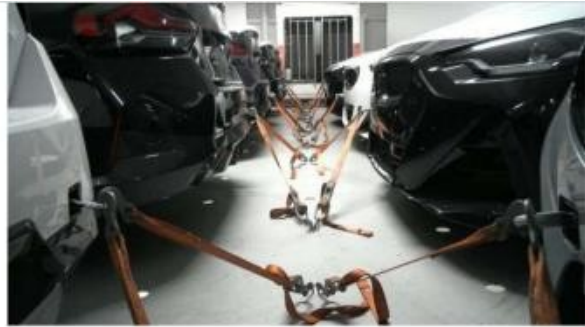
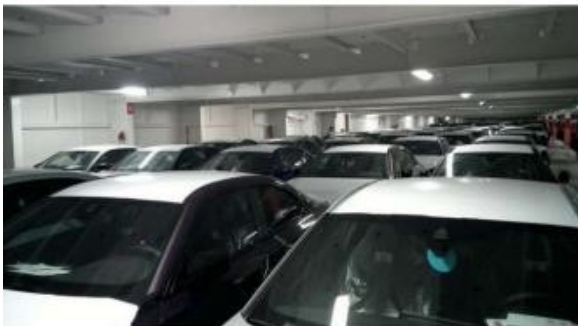
B-3 All vehicles parked correct distances with bumpers in line/sides/walkway/bulkheads/deck head and model by model. Minimum space to RoRo units ca. 1m.

The cars parked good in distance between bumpers and mirrors. Good distance also to boardwall and pillars. Loaded model by model.

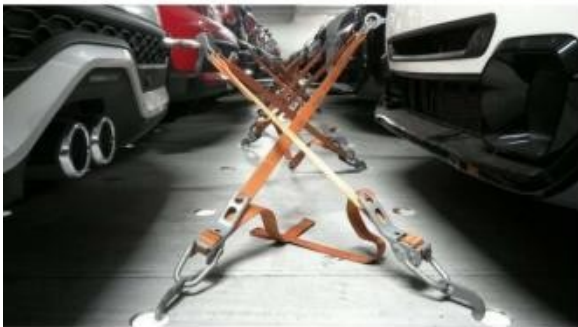
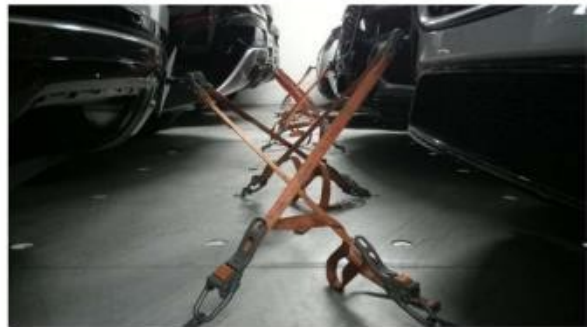
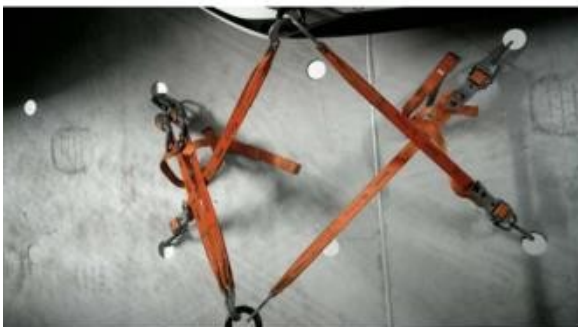
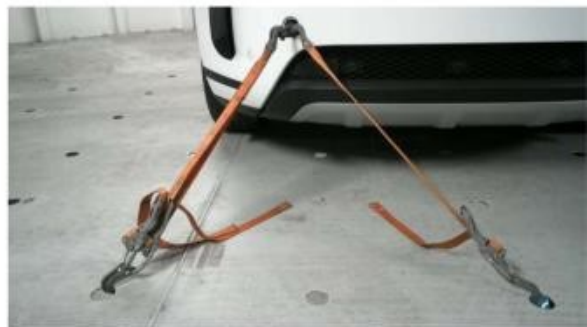
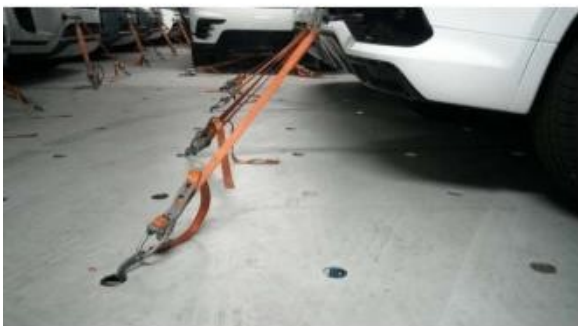
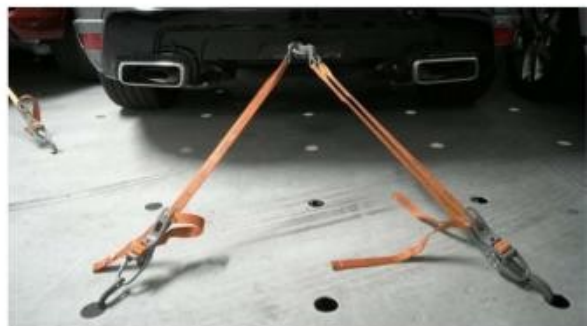
B-6 Lashing done to manufactures requirement (pressured/twisted/lashing angle/hook attachment). Usage of wedges. Rim lashing at MB code666.

Lashing done good in angle and lengths.

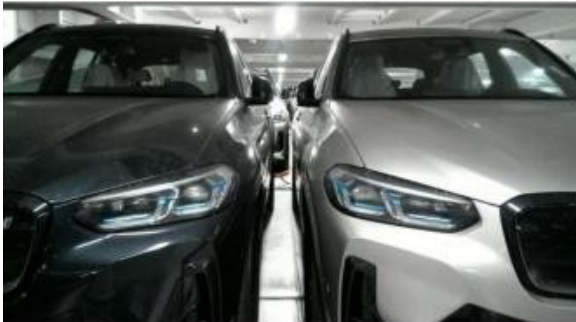
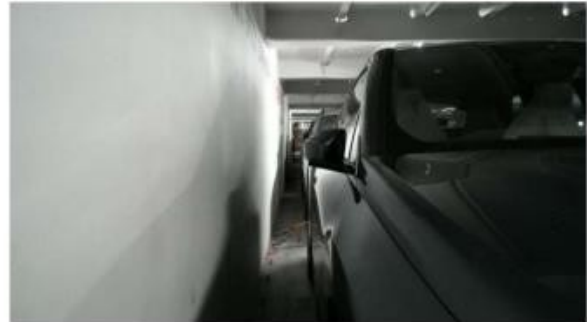
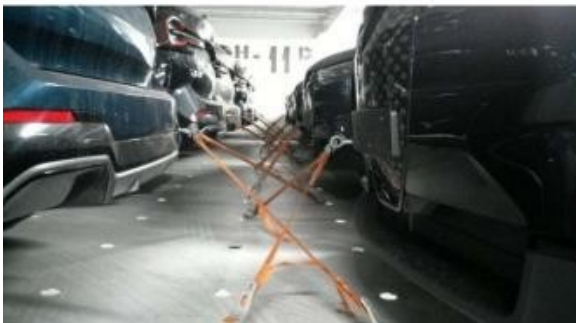
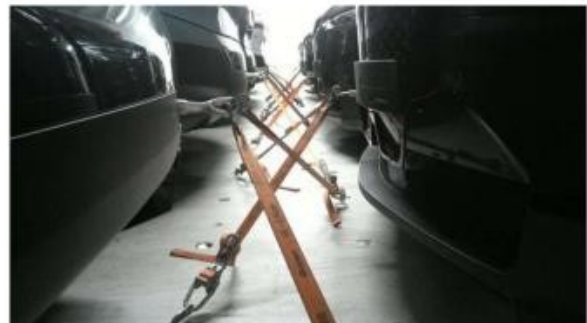
B-7 Stowage of electrical cars accordingly to K-Line requirements (10cm door/door and 30cm - with ibolt 50cm bumper/bumper) and corresponding stowage plan.

Found EV stowed in between regular stow.

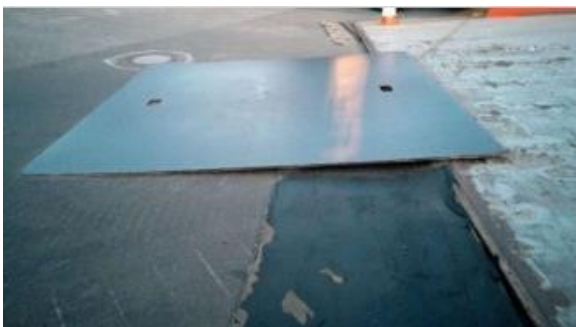
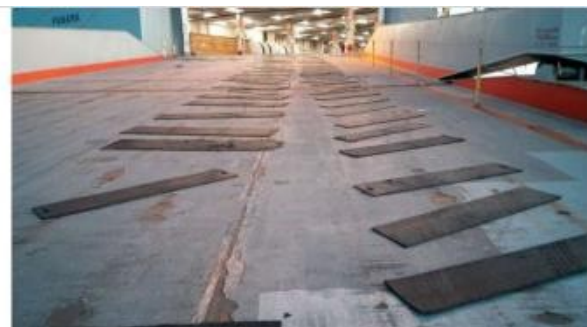
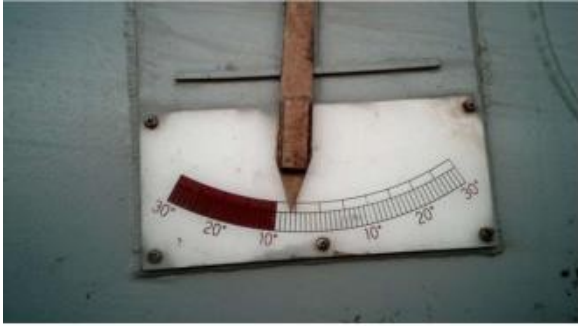
C-1 Proper ramp angle (8 degree) and protection measures at ramp for H&H cargo.

Ramp was well prepared with top ramp angle for loading and discharging, as also protection measurements. Steel plate was placed at stern ramp.

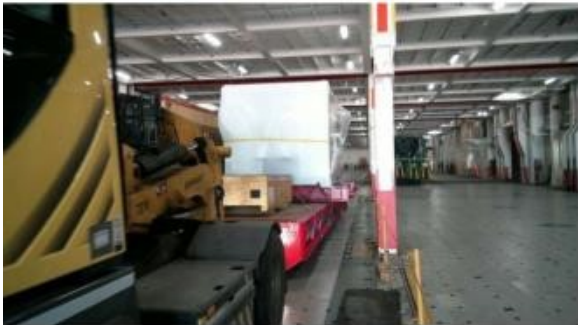
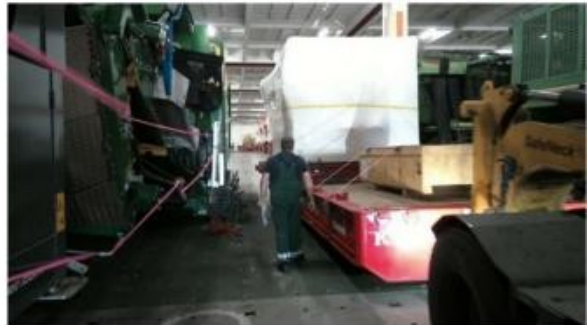
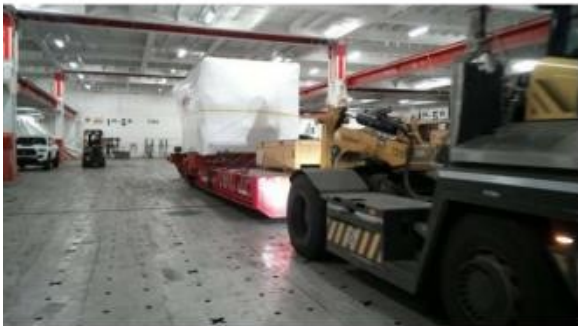
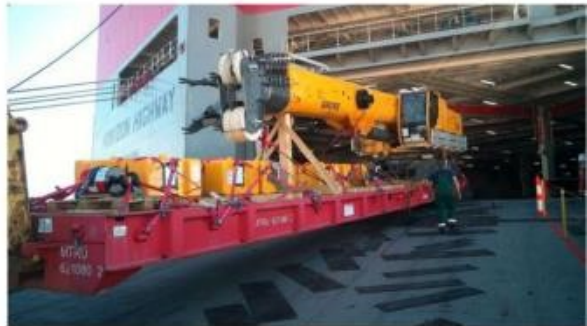
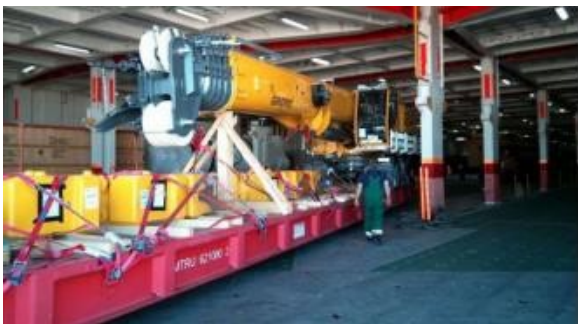
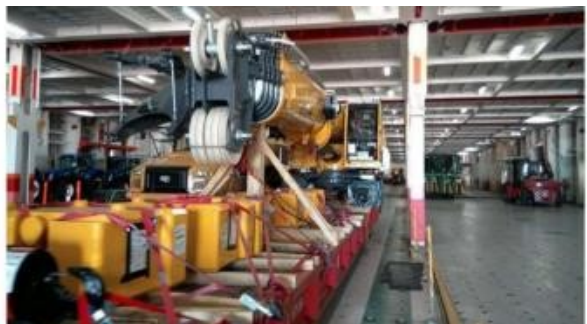
C-2 Safe handling H&H units during loading/discharging. Stevedore escort H&H onto ramp.

Good handling during loading, drive carefully on the ramps. Safety handling with tugmaster into final position. Driver acts attentive to stevedores handsigns.

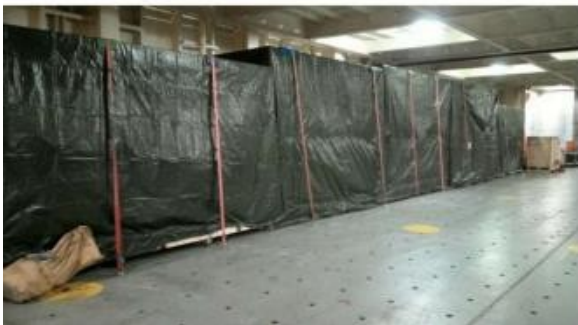
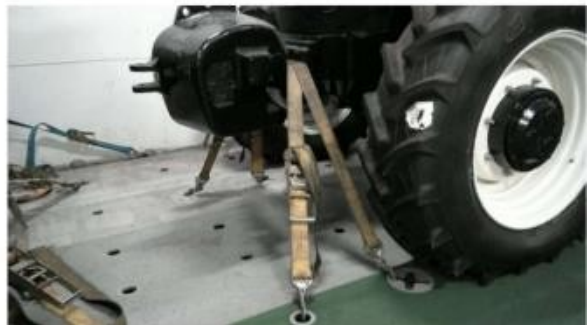
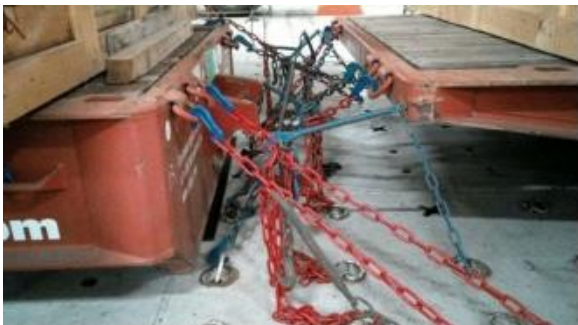
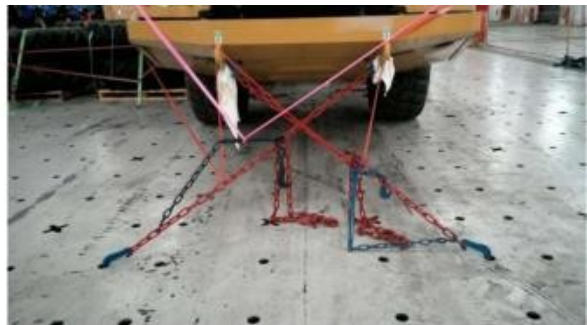
C-3 Lashing and cargo protection of H&H units.

The stevedore used clothes as damage protection on lashing points.

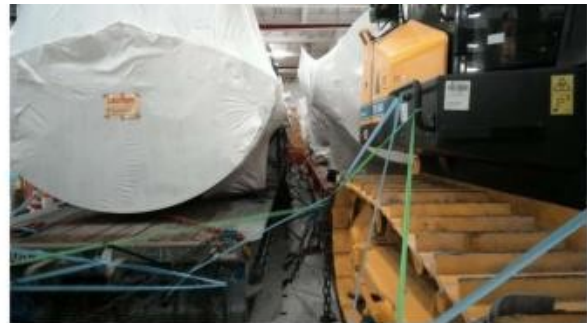
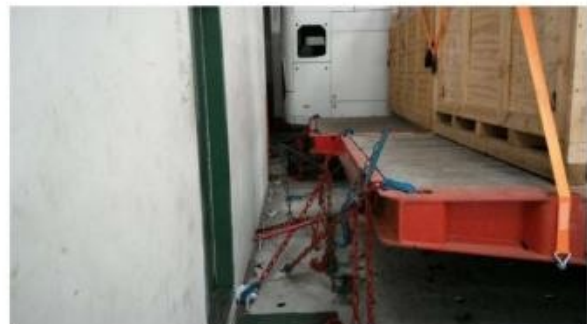
C-5 H&H cargo stowing on decks and proper stowage on rolltrailer (Mafi).

Good stowage with sufficient space for lashing.
