General Information

Carrier	PQC
Vessel	PQC VESSEL
Voyage	001 002
Operation	Post-Discharge and Pre-Load
Port	Bremerhaven
Berth	NH AK1

Audit Results

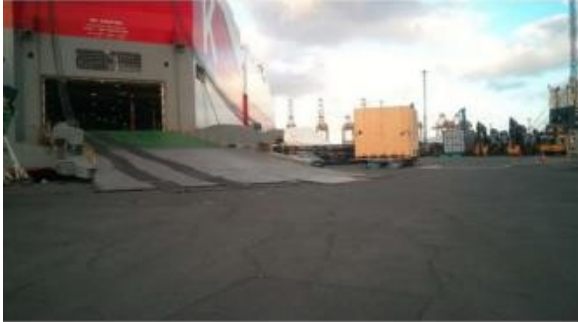
A-1 General condition Terminal.

Operations area next to the ramp was clean and without complaint.

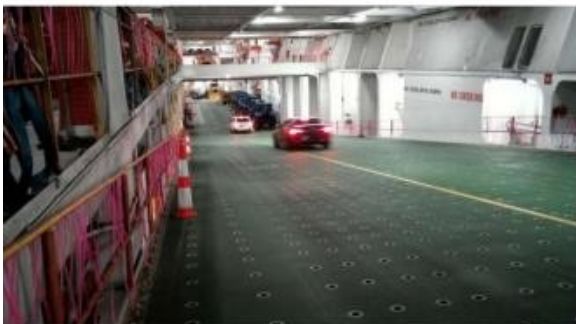
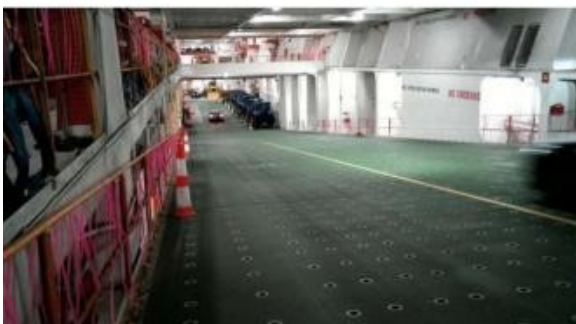
B-1 Safe speed, careful driving and 10m distance between two cars on driveways and ramps.

The drivers drive safely + carefully.

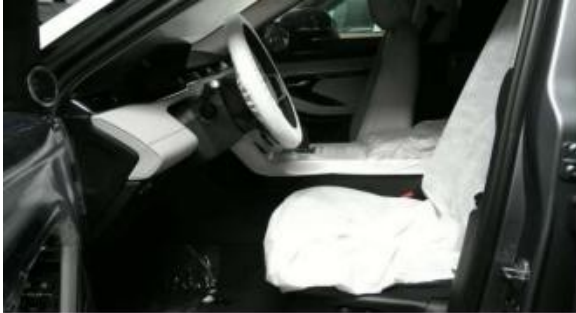
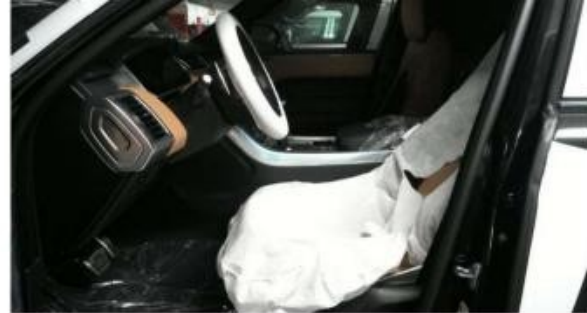
B-2 Vehicles stowed in accordance to the manufactures requirements (key, brake, seatposition, seatcover). Steering wheel in right position.

Meeting the manufactures requirements.

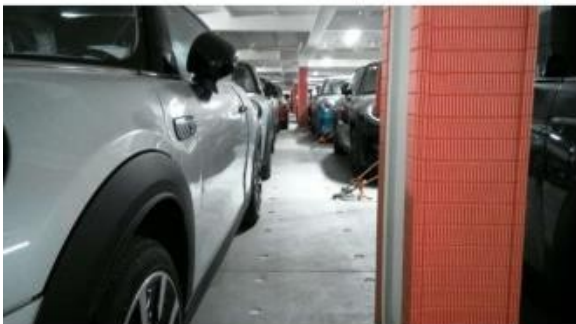
B-3 All vehicles parked correct distances with bumpers in line/sides/walkway/bulkheads/deck head and model by model. Minimum space to RoRo units ca. 1m.

The cars parked good in distance between bumpers and mirrors. Good distance also to boardwall and pillars. Loaded model by model.

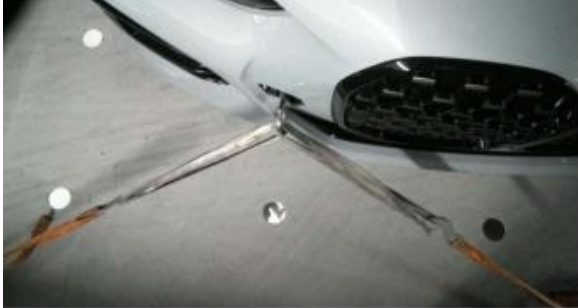
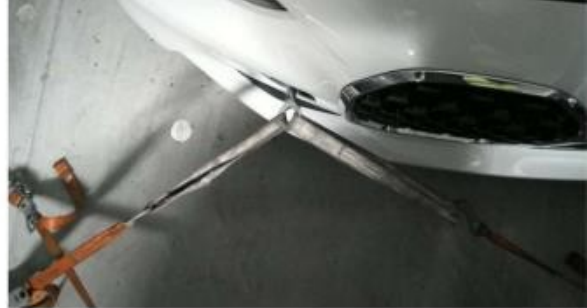
B-4 Cars spot check of loose/missing i-Bolts. Lashing with slings performed at cars with short sized i-bolts or unfavourable stowage position.

Cars with short sized i-bolt were lashed using slings as extension.

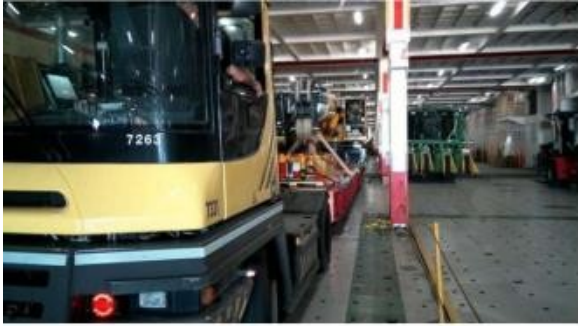
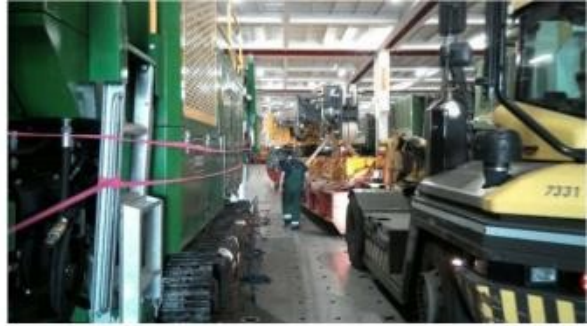
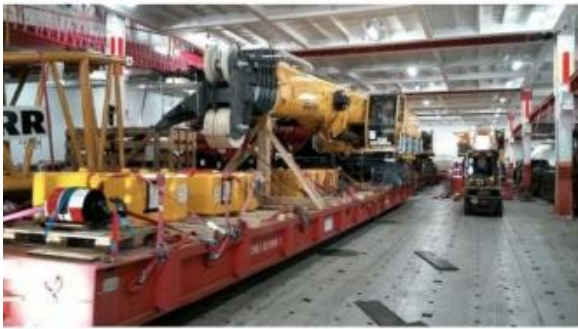
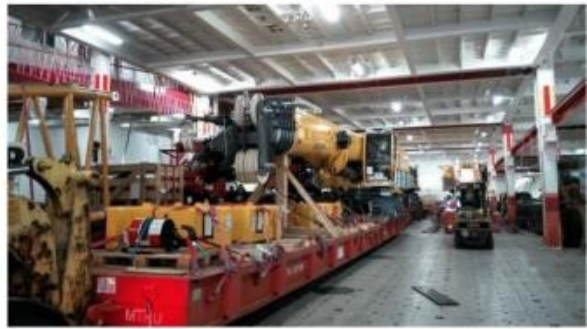
Good handling during loading, drive carefully on the ramps. Safety handling with tugmaster into final position. Driver acts attentive to stevedores handsigns.

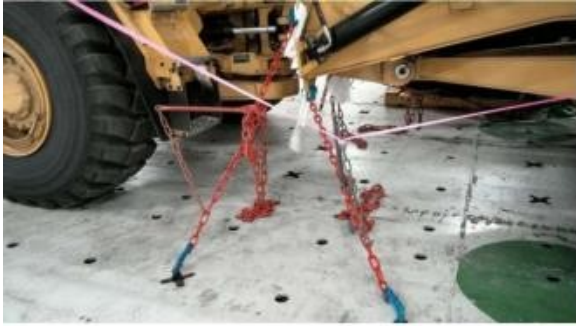
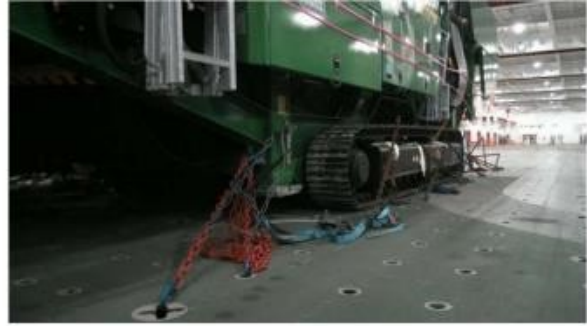
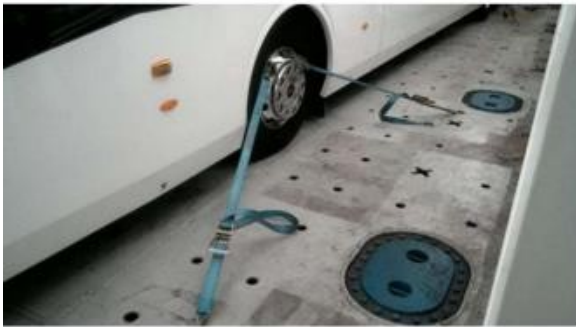
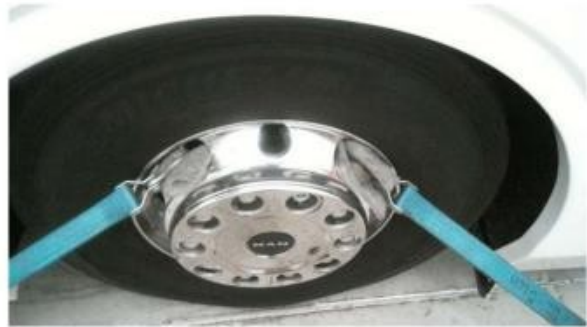
The stevedore used clothes as damage protection on lashing points.

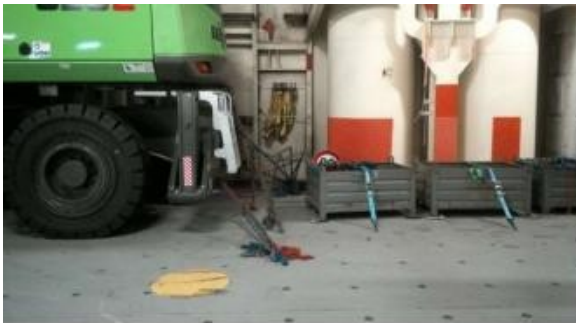
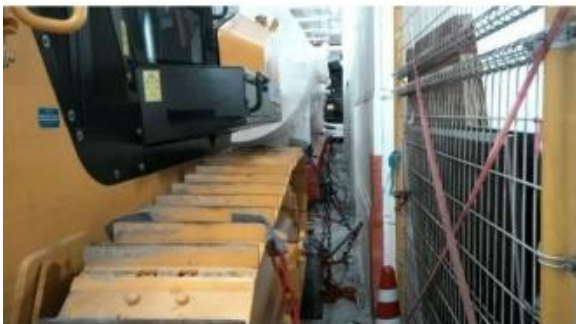
C-5 H&H cargo stowing on decks and proper stowage on rolltrailer (Mafi).

Good stowage with sufficient space for lashing.
